## RESEARCH MEMORANDUM

MECHANISM OF START AND DEVELOPMENT OF AIRCRAFT

CRASH FIRES

By I. Irving Pinkel, G. Merritt Preston, and

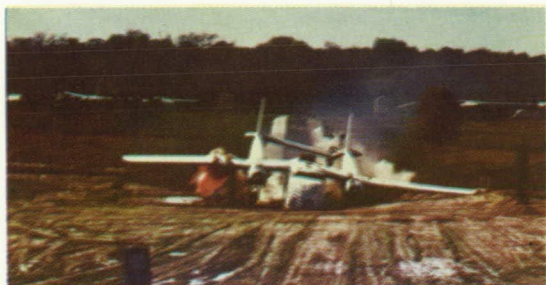
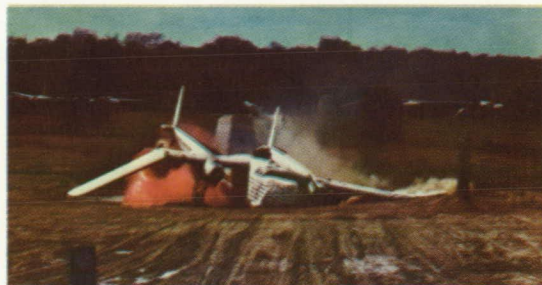
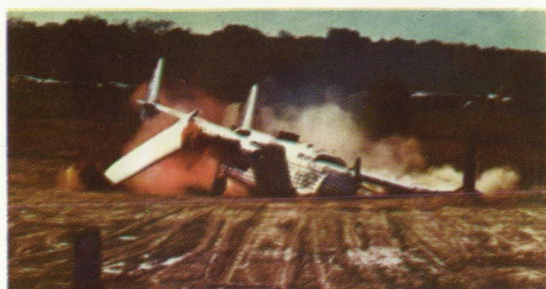
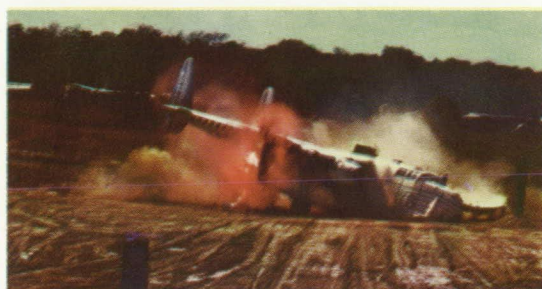
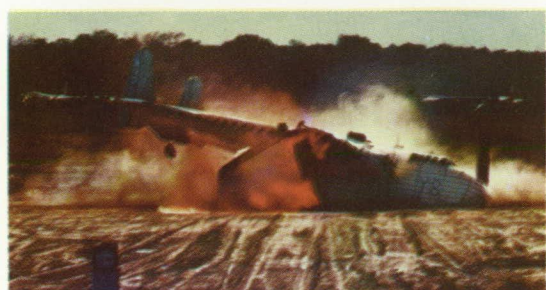
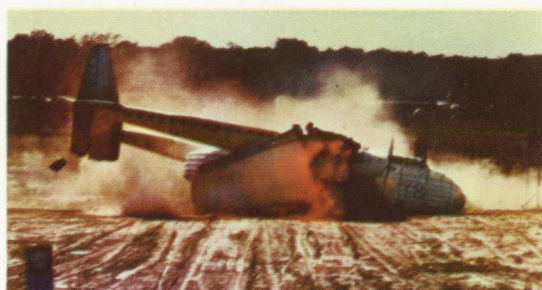
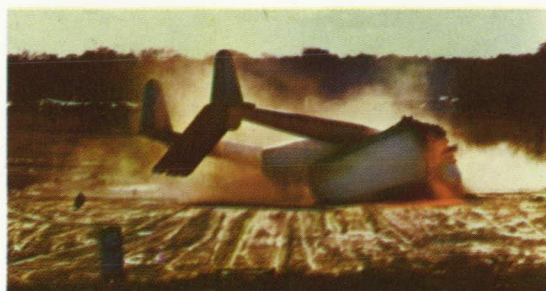
Five of the airplanes equipped with the inerting system that did not burn are shown in figure 40, taken when the airplanes came to rest after crash. A sixth airplane, likewise equipped, was subjected to a ground loop (fig. 41) and did not burn either.

Figure 41. - Ground-loop crash. (Fuel dyed red.)

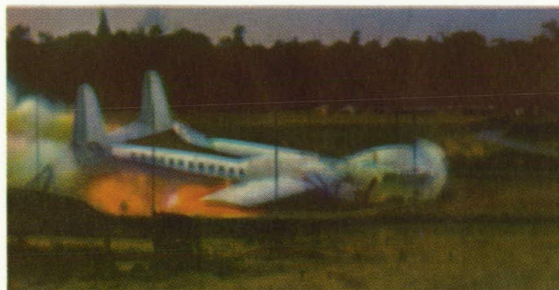
Figure 43. - Damage to forestructure of airplane produced by impact with ground 0.72 second after impact with barrier in high-contact-angle crash. Airplane speed, 100 feet per second.

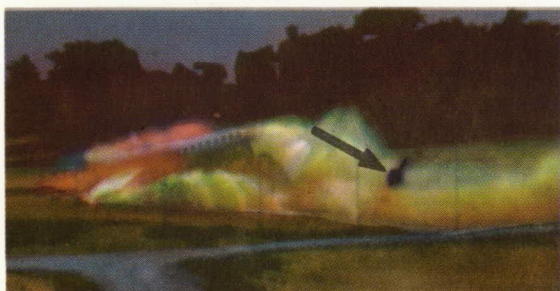
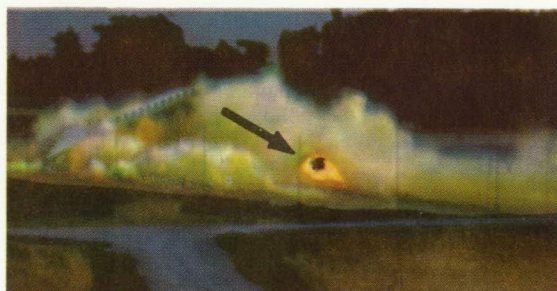
In order to determine whether or not ignition sources are created by the mechanical rending of the aircraft structure in a severe impact, another crash was conducted in which a  $16^\circ$  contact angle between the airplane and the ground occurred. The ground beyond the crash barrier, on which the airplane comes to rest, was sloped and hollowed to give the desired angle of contact. A photograph of the crash area arranged for this crash is shown in figure 42. The crash barrier was maintained in its standard configuration with two abutments and poles for the wing tank on both sides of the airplane. The known ignition sources were inerted in the usual manner. The marked damage to the forestructure of the airplane upon impact with the ground is evident in figure 43 taken 0.72 second after impact with the barrier. Extensive coverage of the airplane with fuel did occur as shown in figures 16(a) and 16(b), which are photographs of the fuel mist development experienced in this crash. Because of the time lag associated with the movement of fuel out of the tanks, the time of the maximum forward surge of the fuel follows the period of peak airplane deceleration by 1.1 seconds. No ignition of the fuel occurred around the deforming structure, indicating the absence of ignition sources of sufficient duration to ignite the fuel in this instance. Ignition sources covered by the inerting system were inactive in spite of the severe nacelle damage sustained. As the airplane slowed to rest, however, the left wheel strut tumbling through air behind the airplane (fig. 44(a)) ignited the fuel in the airplane's wake when the strut approached the ground approximately 60 feet behind the left wing (fig. 44(b)). The fire moved through the fuel mist and liquid fuel on

the ground (fig. 44(c)), toward the airplane where ignition of the fuel in the wings exploded both wings (fig. 44(d)). The flame propagation rate through the fuel mist around the airplane was determined as 75 feet per second with a 30-foot-per-second tail wind, giving a net speed of 45 feet per second (fig. 45). The large column of fuel mist suspended in the air is evident from the volume of fire shown in figure 44(d).

From inspection of the terrain in the crash area and inspection of the wheel strut assembly, it was concluded that the ignition source was neither friction sparks nor diesel ignition of the hydraulic fluid in the wheel strut; however, investigation of the electrostatic charge collection on the wheel strut assembly by friction with the dust and the fuel mist in the airplane wake showed that the ignition in this case was most likely produced by electrostatic discharge from the strut to the ground. These studies were made with the same wheel and strut, electrically insulated from the supports as shown in figure 46. Air was blown over the wheel and strut assembly by the blower shown in the figure and dust was metered into the air stream. A dust flow rate of 400 grams per second with an airspeed of 45 miles per hour past the strut generated 1500 volts, sufficient to produce sparks capable of fuel ignition in less than 1/2 second (fig. 47). In the crash, the wheel and strut traveled through the air at 43 miles per hour for 1 second, bounced on the rubber tire, and then traveled through the air for another 1-second period at approximately the same speed.

The only new mechanism of crash fire revealed in this phase of the work with the ignition source inerting system installed in the airplane nacelles is shown in the crash illustrated in figure 44. The landing wheel and strut, which were stripped from the airplane at the crash barrier, followed in the wake of the airplane sliding along the ground. In its passage through the soil dust and fuel mist in the wake of the airplane, the wheel and strut accumulated electrostatic charge, which ignited the fuel behind the airplane when the wheel strut approached the ground, and discharged its accumulated electrostatic charge (fig. 44(b)). The fuel fire propagated through the fuel in the wake to the crashed airplane.

(a) Wheel strut in air before ignition 1.2 seconds after initial impact. Airplane speed, 75 feet per second.

(b) Ignition of fuel mist 2.4 seconds after initial impact. Airplane speed, 24 feet per second.

(c) Spread of fire 2.9 seconds after initial impact. Airplane speed, 15 feet per second.

(d) Spread of fire 3.9 seconds after initial impact. Airplane speed, 0.

Figure 44. - Ignition of fuel mist by electrostatic charge on landing gear in high-contact-angle crash. (Fuel dyed red.)

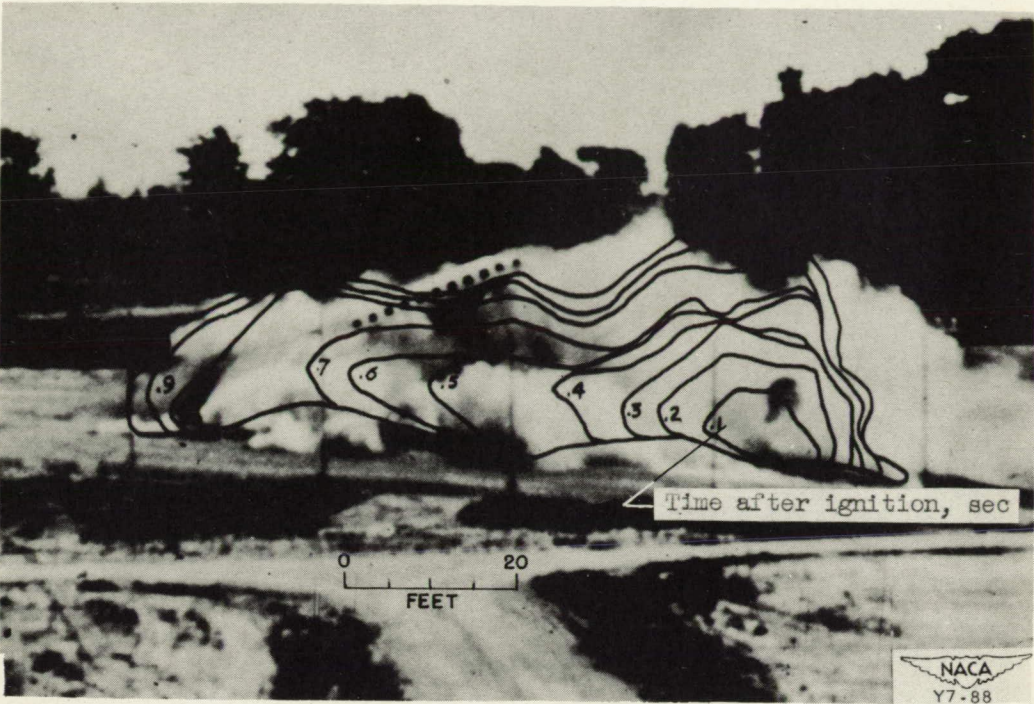
Figure 45. - Contour of fire propagation through fuel mist after ignition in high-contact-angle crash.

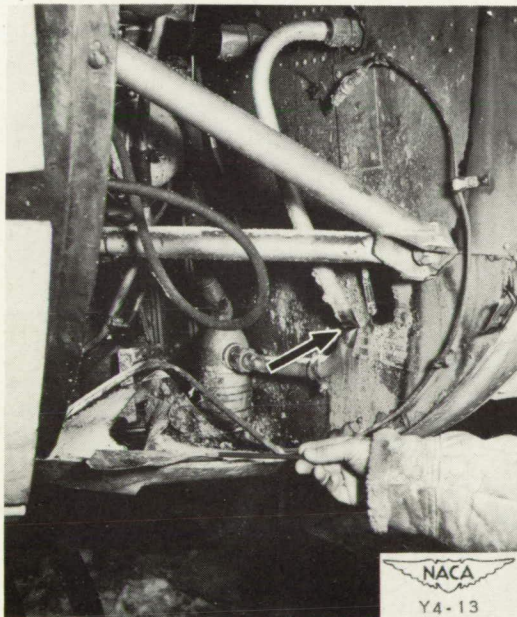
Figure 48. - Damaged fuel line cut by flying propeller tip.

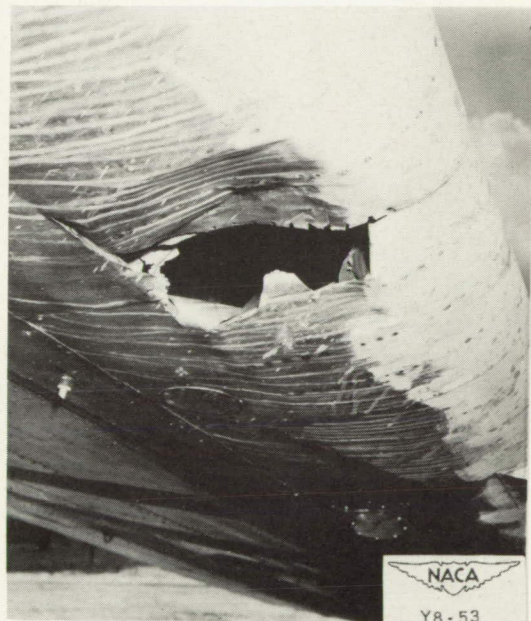
Figure 49. - Wing fuel tank ruptured by flying propeller tip.

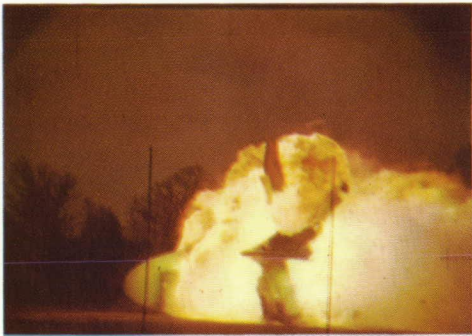
Figure 51. - Explosion of wing due to ignition of fuel vapors in wing and wing tanks.

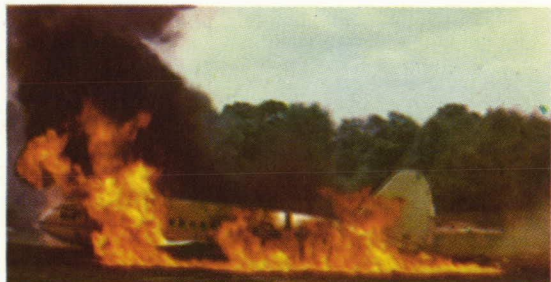
(b) 4.0 seconds after ignition.

Figure 54. - Flame movement through fuel on ground behind airplane.

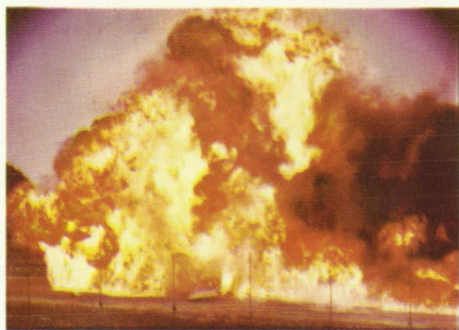
(a) Fuel mist fire at its maximum; 3.0 seconds after ignition.

Figure 55. - Rapid burning of fuel mist.

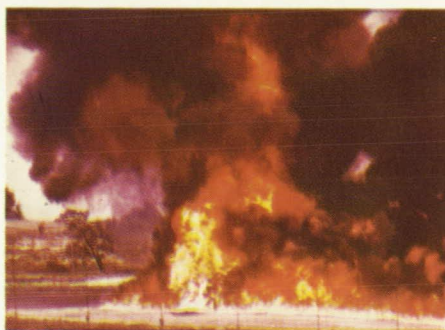
(b) Fuel mist fire with rising column of smoke and burning core of fuel mist; 5.3 seconds after ignition.

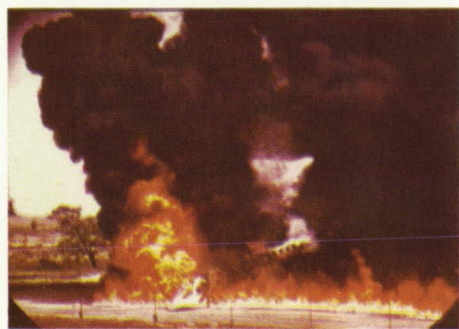
If ignition occurs while appreciable fuel is suspended in the air as mist, the heat released from its combustion often represents most of the total heat release in the early phase of the fire. Because the fuel in the mist is dispersed through a large volume of air, each droplet is surrounded by a sufficient quantity of air to burn a significant portion of the droplet. The fuel mist is consumed rapidly, therefore, and seldom persists for more than 20 seconds. The fuel mist fire at its early development, shown in figure 55(a), 3.0 seconds after ignition, appears as a solid wall of flame extending 45 feet behind and 65 feet above the airplane. The heated fuel mist rises as it burns. The heat radiated to the airplane from burning fuel mist lessens rapidly as the fuel mist rises and acquires at the same time an envelope of opaque black smoke characteristic of petroleum fuels (such as gasoline) burning in the open air. In this phase the mist fire has the appearance shown in figure 55(b), 5.3 seconds after ignition. The burning core of the mist, visible in the figure, is the last to burn out leaving the fuel evaporating from the wetted surface of the airplane and the ground to continue the fire as shown in the photograph of figure 55(c).

(c) Fire from fuel evaporating from wetted surface of airplane and ground; 10.0 seconds after ignition.

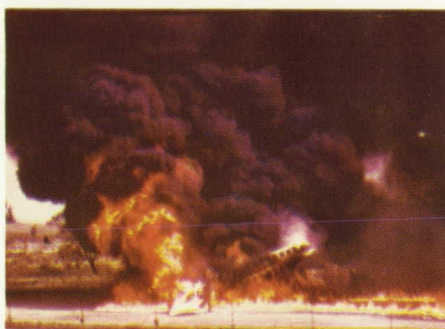
Of the fuel spilled on the ground, a large portion soaks rapidly into dry unfrozen soil. When the crash takes place on sloping ground, as in the studies conducted here, the pools of fuel that collect are quite shallow and only during the first few minutes after the crash are there appreciable quantities of liquid fuel exposed in the airplane slide path to provide combustible vapors in large quantities. These vapors rise and burn to form a column continuous with the burning fuel-mist mass. The lower portion of the towering column of smoke and fire shown in figure 55(c) is provided by this vaporized fuel. Some of the fuel that soaked into the ground released vapors at a sufficient rate in hot environment of the fire to maintain small fires that burn close to the ground (fig. 55(d)).

(d) Fire produced by fuel that soaked into ground vaporizing and burning in column continuous with burning fuel from tanks; 19.0 seconds after ignition.

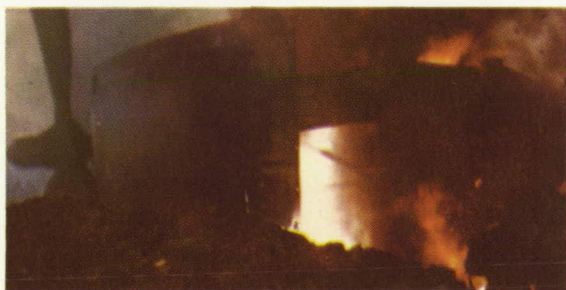
Figure 56. - Magnesium portions of engine burning during crash.

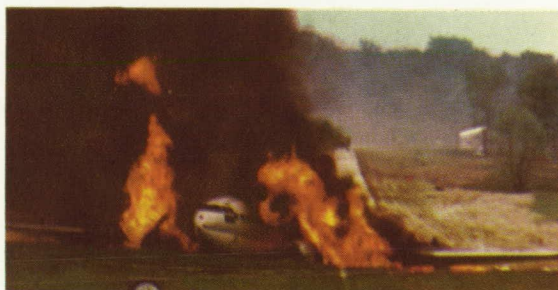
Figure 57. - Flames from burning fuel in wing tanks licking sides of fuselage.

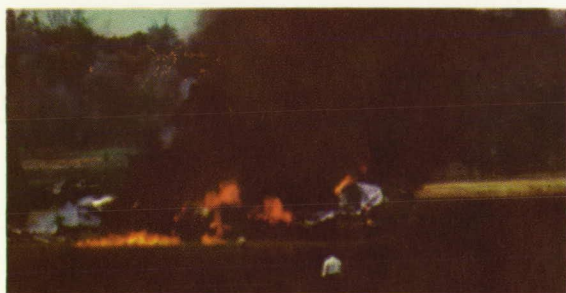
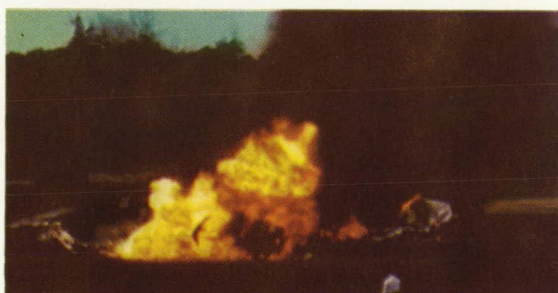
The airplane fire reaches several secondary peak intensities before it finally burns out. Barring explosions, the first of these peaks usually occurs when the fire burning at the fuel tanks enlarges the openings from which the fuel issues or opens undamaged tanks and increases the rate of fuel spillage. Such enlargement of the fuel-tank openings or burn-through of otherwise intact tanks, below the fuel level, will occur sooner with bladder-type tanks than with metal tanks which have good thermal conductivity. The cooling provided by the fuel in the tank retards burning of the tank walls. Wing explosions are usually followed by a marked resurgence of the fire because of the associated fuel scattering (figs. 51 and 52). Such explosions may occur when the fire first propagates to the wing from the point of ignition or after the wing fire has been in progress. Exploding elements of the hydraulic system such as wheel struts softened in the heat of the fire will spread flaming hydraulic fluid with spectacular effect (figs. 58(a) and 58(b)).

(a) Fire before explosion.

(b) Build-up of fire due to spread of flaming hydraulic fluid.

Figure 58. - Fire produced by exploding hydraulic-landing-gear strut.

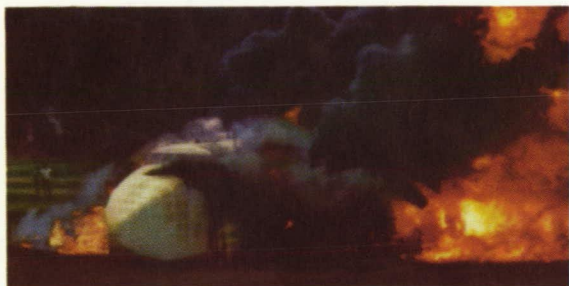
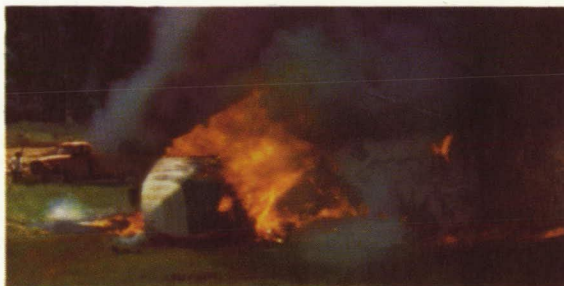
When the fire burns through the fuselage skin and the combustibles within are made available, the fire development achieves another peak. Exploding hydraulic system accumulators add the hydraulic fluid to this fire and promote its spread inside the fuselage. The fire within the fuselage burns slowly at first if the fuselage is essentially intact and limited combustion air is available. At this time large volumes of smoke, representing condensed and partially burned hydraulic oil vapors and other volatile materials, are often observed issuing from the fuselage, as shown in figure 59(a). As the fuselage skin is consumed in the fire, access for additional air develops with a corresponding further fire development. When a large hole burns through the skin at the top of the fuselage, the air flow is further promoted by chimney action. The fuselage fire attains its peak at this time. A view of the fuselage fire (fig. 59(b)) shows the combustible smoke that issued earlier from the fuselage (fig. 59(a)) burning with a bright flame. The appearance of flame at the door frame shows the fuselage being consumed by fire from within.

(a) Smoke and hydraulic oil vapors issuing from fuselage nose.

(b) Resulting fire after burn through of skin of fuselage nose.

Figure 59. - Development of hydraulic fluid fire within fuselage.

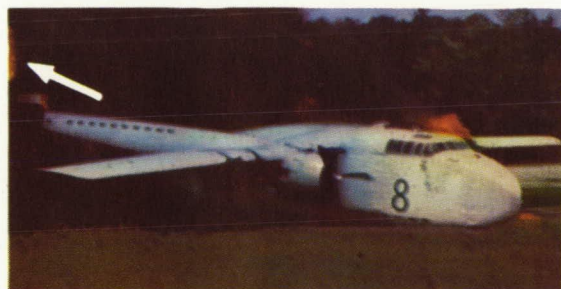
Figure 62. - Burning fabric on tail surfaces ignited by fuel-mist flash fire.

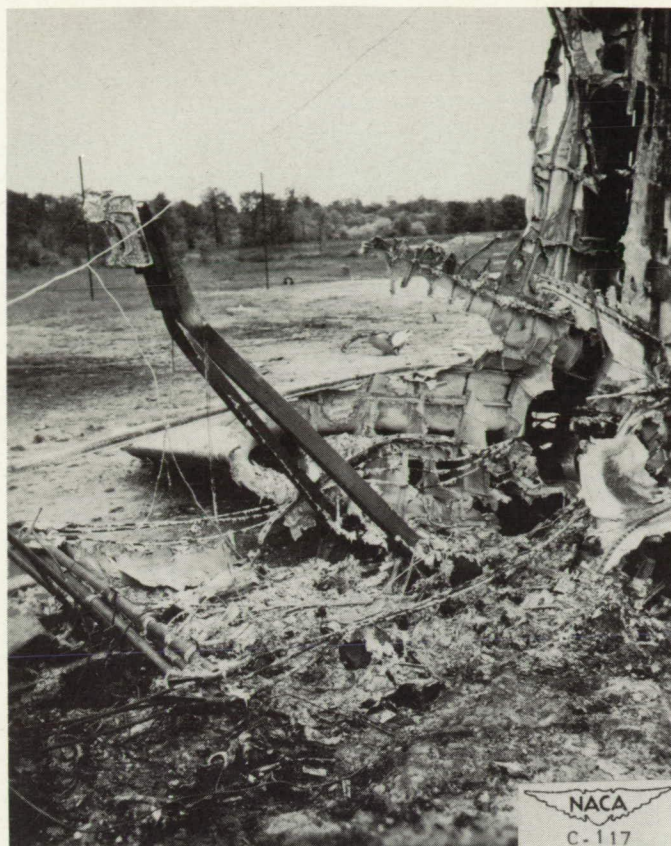
Figure 63. - Structural elements melted in a typical crash fire.

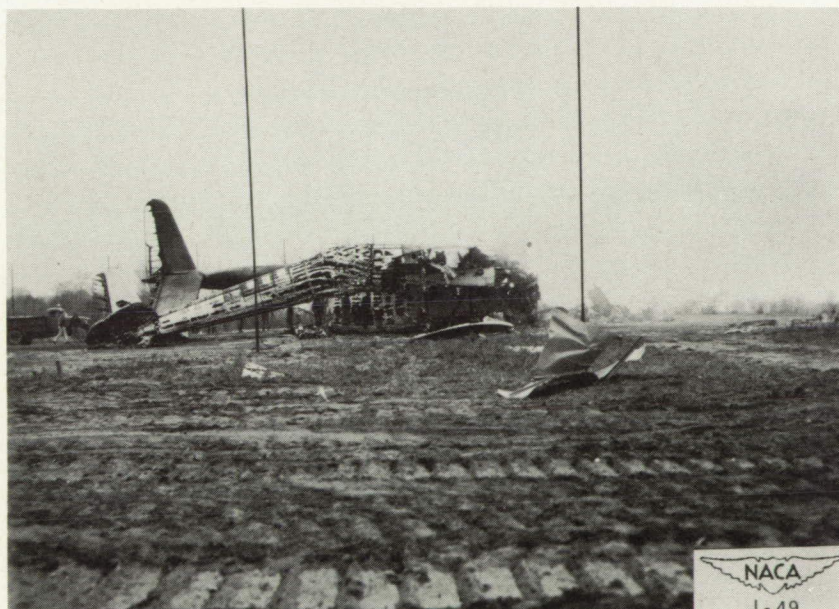
Figure 64. - Structural collapse due to melting and burning of skin and structural members.

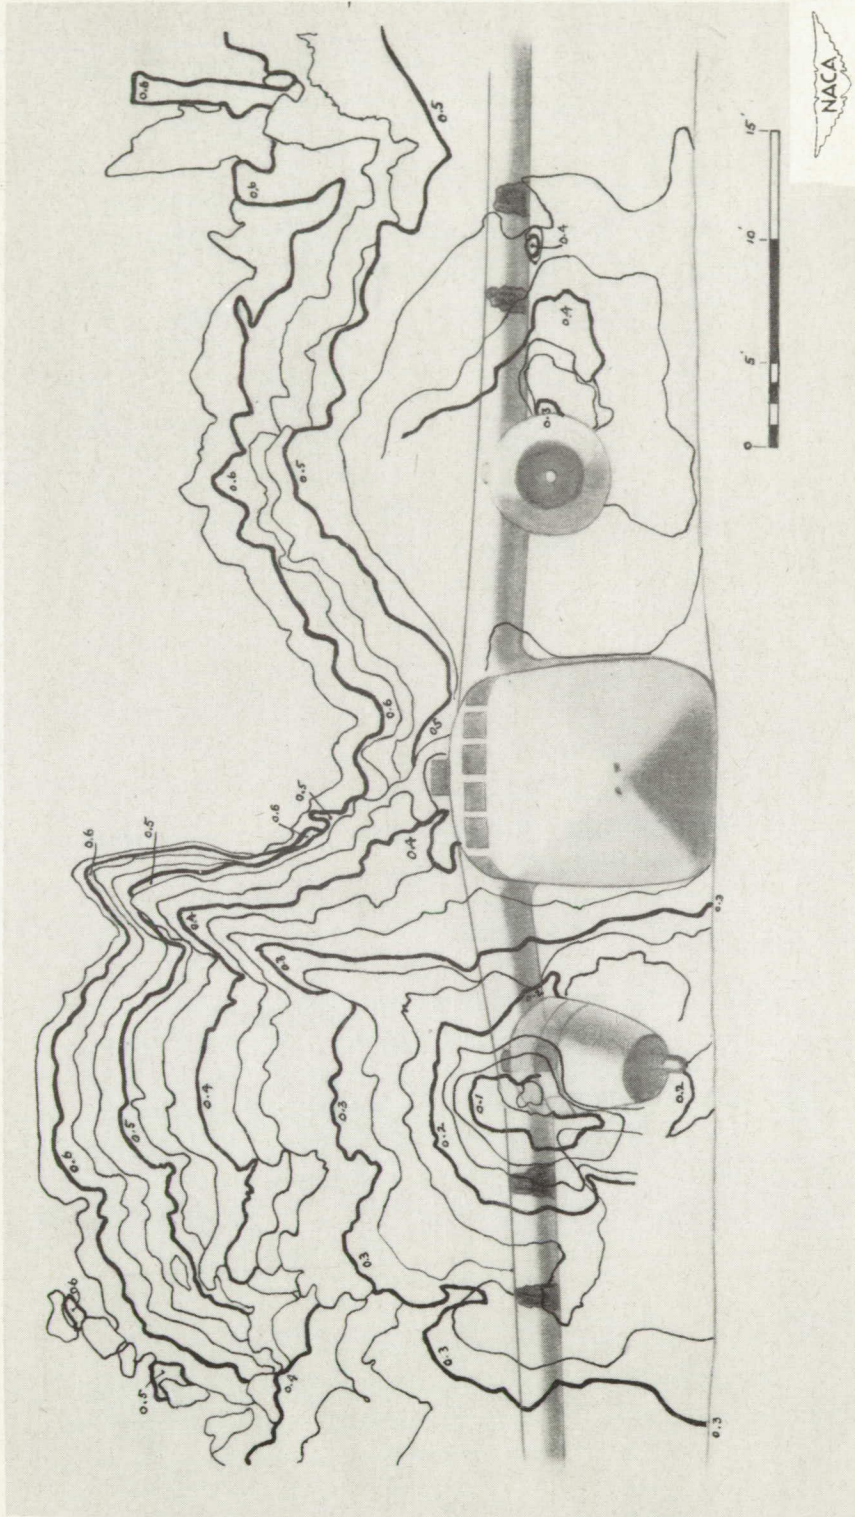
Figure 65. - Map of progress of fire following ignition as it appears to camera viewing airplane head-on. (Numbers refer to time after ignition in seconds.)

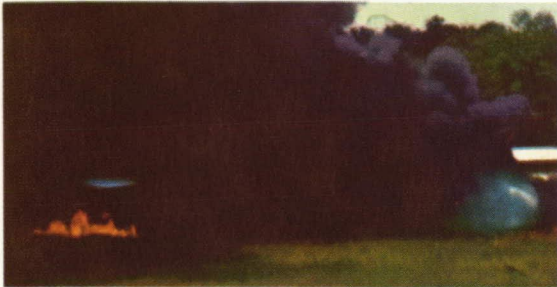
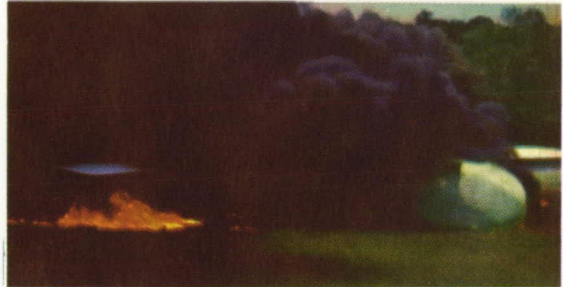
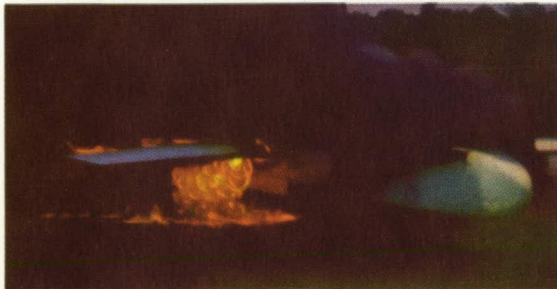
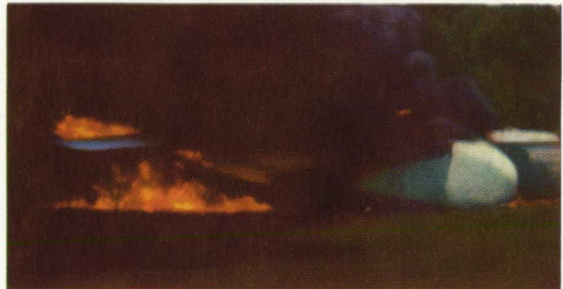
(a) Fire burning on ground on right side under empennage of airplane 76 seconds after ignition of left side of airplane.

(b) Progress of fire burning on ground on right side 84 seconds after ignition of left side of airplane.

(d) Ignition of fuel in right wing tanks 107 seconds after ignition of left side of airplane.

(c) Ignition of fuel pouring from right wing tanks 98 seconds after ignition of left side of airplane.

Figure 66. - Cross-over of fire from left to right side of airplane through fuel trail left on ground by airplane.

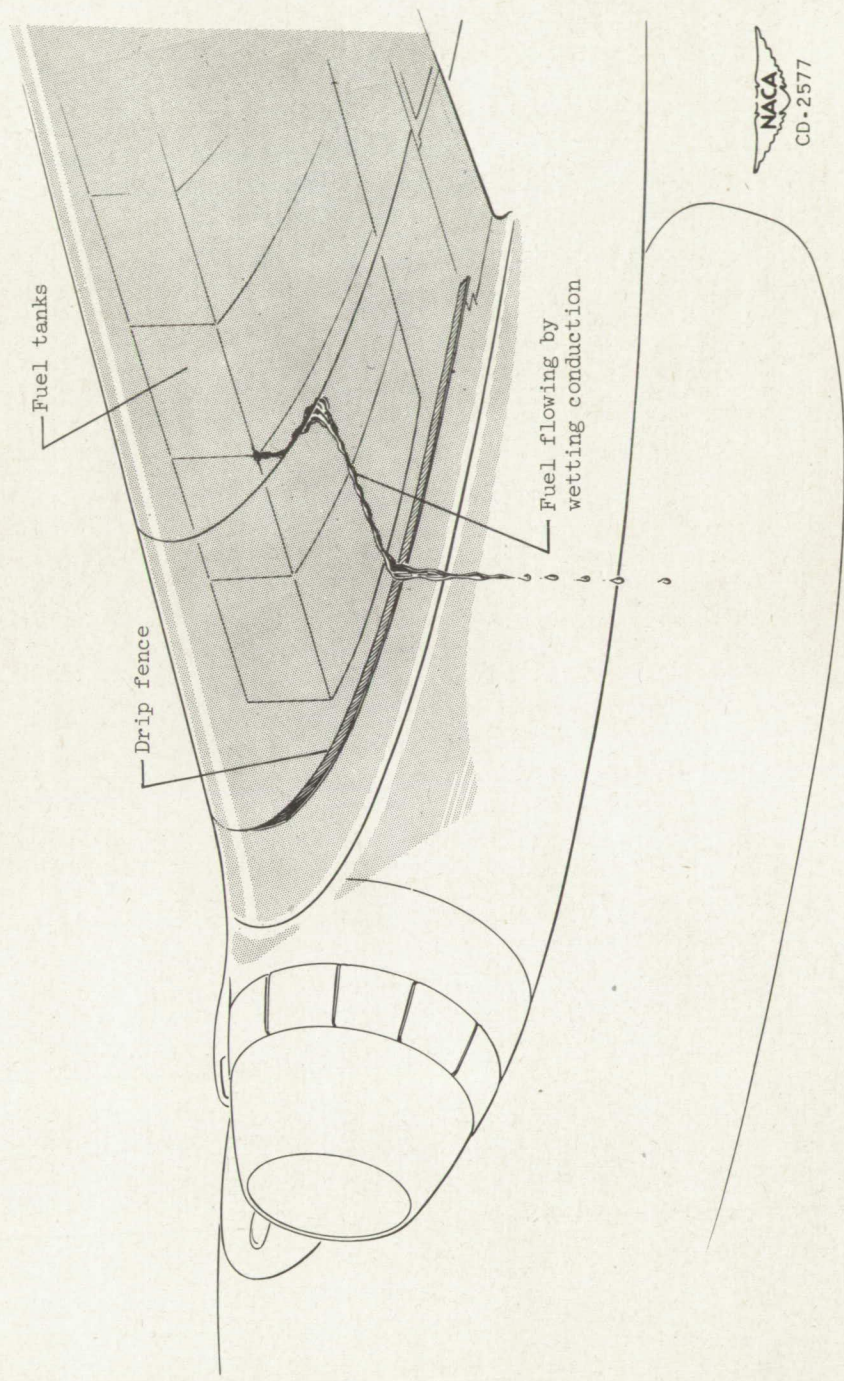
Figure 67. - Drip fence to prevent spanwise flow of fuel from fuel tanks to nacelle by wetting conduction on lower surface of wing.
